Gang der Grabung: Auszüge aus Zaki Y. Saad's „Diary on the excavation of the Department of Antiquities at Helwan“

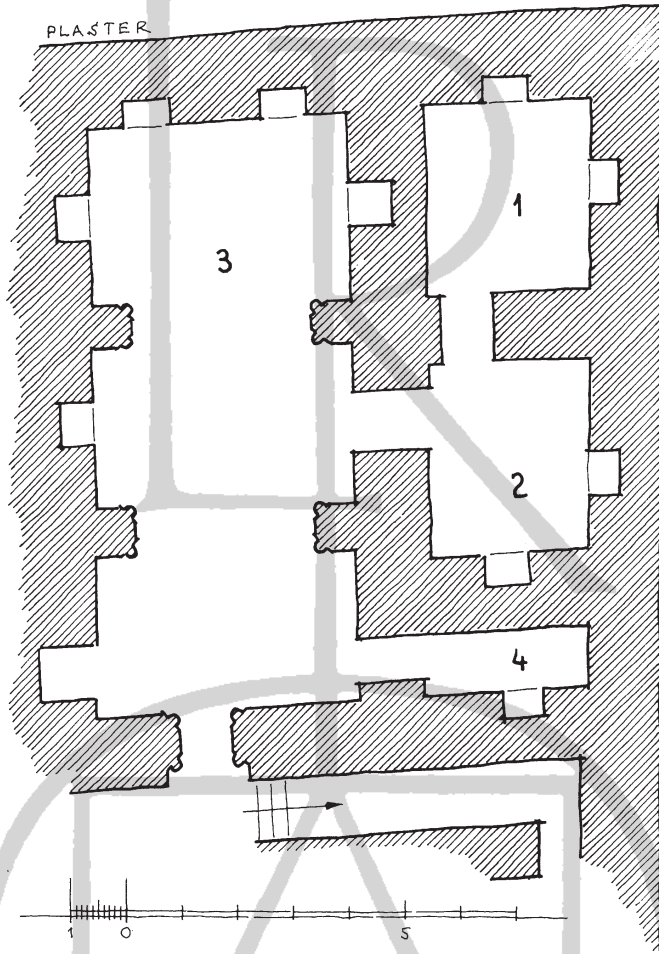
6 October 1948: The clearance of this part yielded a group of two chambers to the north (**Fig. 1**), probably a small passage? And to the south a big hall.

Fig. 1. Group of rooms at the south-west corner

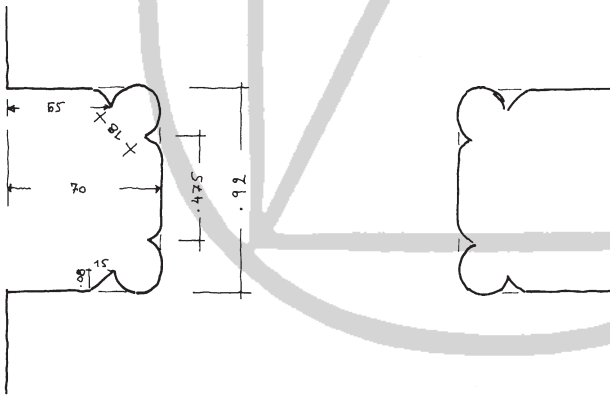
10 October 1948: More rooms have been discovered in one line to the east of the first room. To the south of this line is a big hall (?)¹². The rooms have closed windows in the walls (niches). Room 1 has two, one in the west wall and another in the north wall. A door in the east wall from the south as a communication with the rooms to the east. Room 3 has two niches on the west wall and one niche in each of the north and south walls. To the west is a wide entrance with two jambs on each side decorated with semi-columns (**Fig. 2**)¹³.

Fig. 2. Jambs with columns on the sides

13 Maße nach M. A. M. RASLAN.

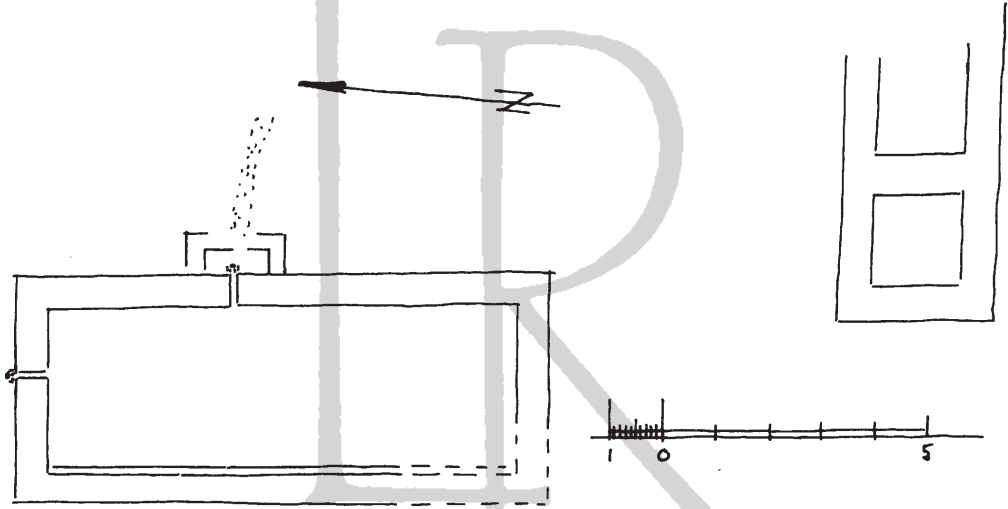
Fig. 4. Cistern with two lion's head water spouts and rectangular building to the south-east

4 December 1948: A small basin, probably a bath, was cleared. The bottom was made higher in a later time. It has two draining pipes one in the north and another in the east (Fig. 4). Both of them end from outside by a mouth in form of a stylized lion's head and the mouth is just the opening out of which the water passes. The basin in which these two draining pipes are placed takes its water from a small canal coming from the southern outside of the whole building²⁰.

6 December 1948: A building to the south-east of the basin has been located (Fig. 4).

19 Es handelt sich hierbei offensichtlich um eine voreilige, später nicht richtiggestellte Deutung eines zunächst unvollständig freigelegten Befundes, denn der genannte Löwenkopfspeier gehört zu den Ausflüssen des großen Beckens auf der Westseite des Hofes (s. die folgende Notiz vom 4. Dezember 1948), während die genannte „drain“ nur zufällig in Richtung zu diesem Becken verläuft; jedoch kann sie gut eine Abflußleitung aus diesem Becken sein, nicht ein Zufluß, wie Z. SAAD unter dem 4.

20 s. hierzu die vorige Anm.; auf einer Skizze im Tagebuch (hier Fig. 4) ist freilich eine sich nach Osten fortsetzende Abflurrinne ergänzt. Richtig gestellt wurde diese irrierte Ansicht am 19.12. 1948.

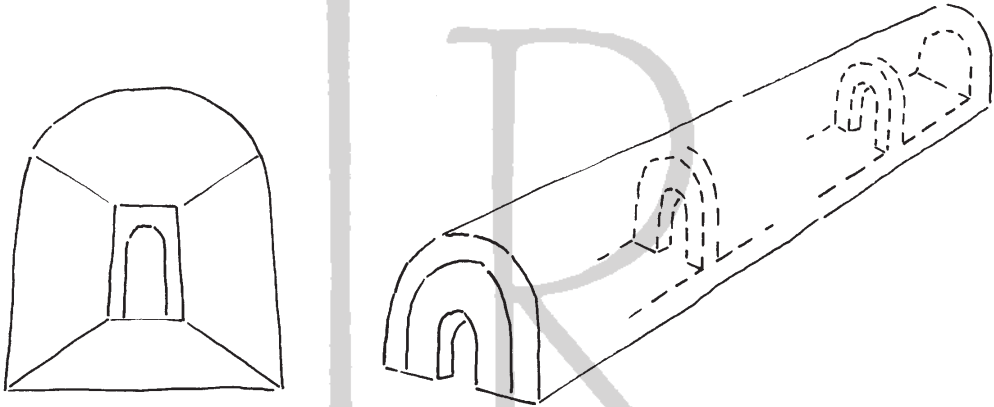
Fig. 5. Basin divided into three parts with two partitions in the middle

11 December 1948: Cleared the basin. It is divided into three parts with two partitions, in the middle of which are two vaulted doors (Fig. 5). The vault was plastered and painted with coloured designs. In some of the pieces were found holes, some of them still have glass as small lightning holes?? What was the purpose of this basin??

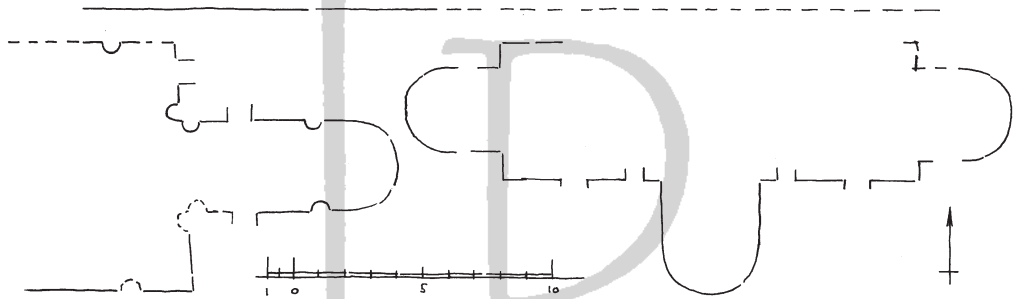
Fig. 6. Triconch and church

19 December 1948: The clearance of the chamber on the south side proved that a church existed behind the semicircle facing west (Fig. 6). The church had a hall and chapel²⁴. A part of it had designs which were copied by Mme Bachatly (see above December 8 and 9). To the west of the church was found a small water channel going outside the whole building and pouring into a pit²⁵. Rostom Bey, Abou el-Naga, Zaki Noor and Raslan Eff. visited the site.

25 Richtigstellung der irrigen Ansicht vom 4.12. 1948; „pit“ steht hier für „channel“.

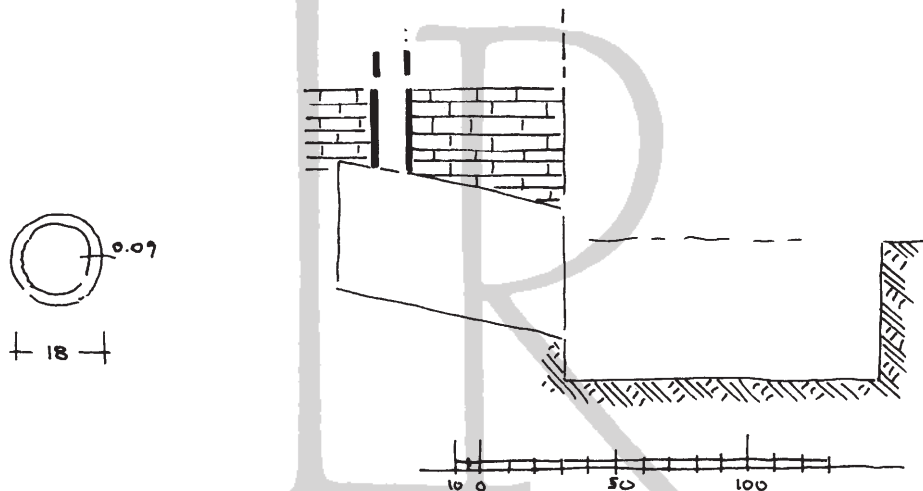
29 December 1948: Clearing the east part of the monastery. To the east of the first chamber was found a drain pipe with a hole in which a circular pottery jar was put in the wall from the exterior part and pours the water into a small pit cut in soft rock (Fig. 7).

Fig. 7. Drain pipe

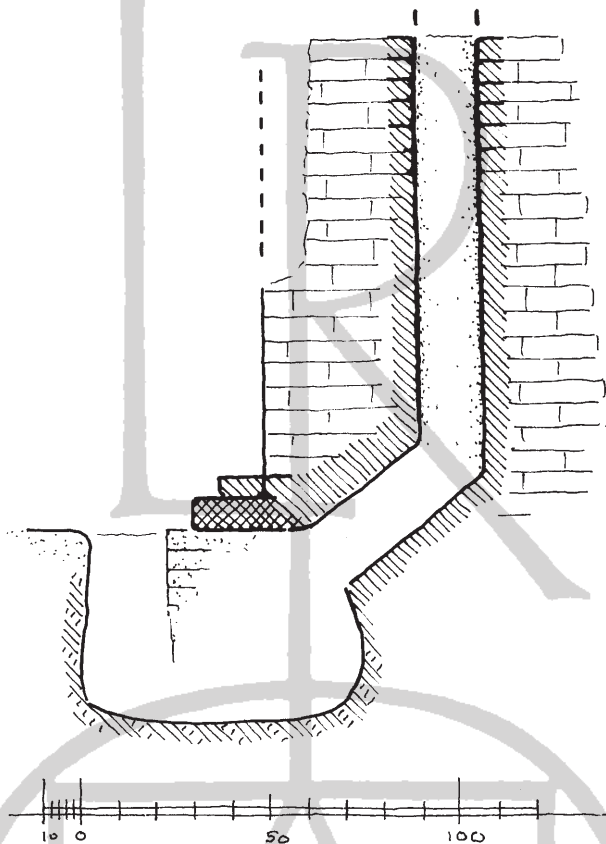
Fig. 8. Drain pipe at the north-west corner of the building

23 January 1949: In the western wall, near the north side, a hole was found. In it is placed a pottery pipe going down. By the foot of the wall was found an opening out of which the water goes out³³. Clearing this place we found the place built with mud-bricks³⁴ and a small rectangular hole cut in the soft rock (**Fig. 8**). Studying this piece and comparing it with the other on the east-north wall³⁵, one judges that both of these holes fitted with pottery were to let the rain get down from the roof to the ground.

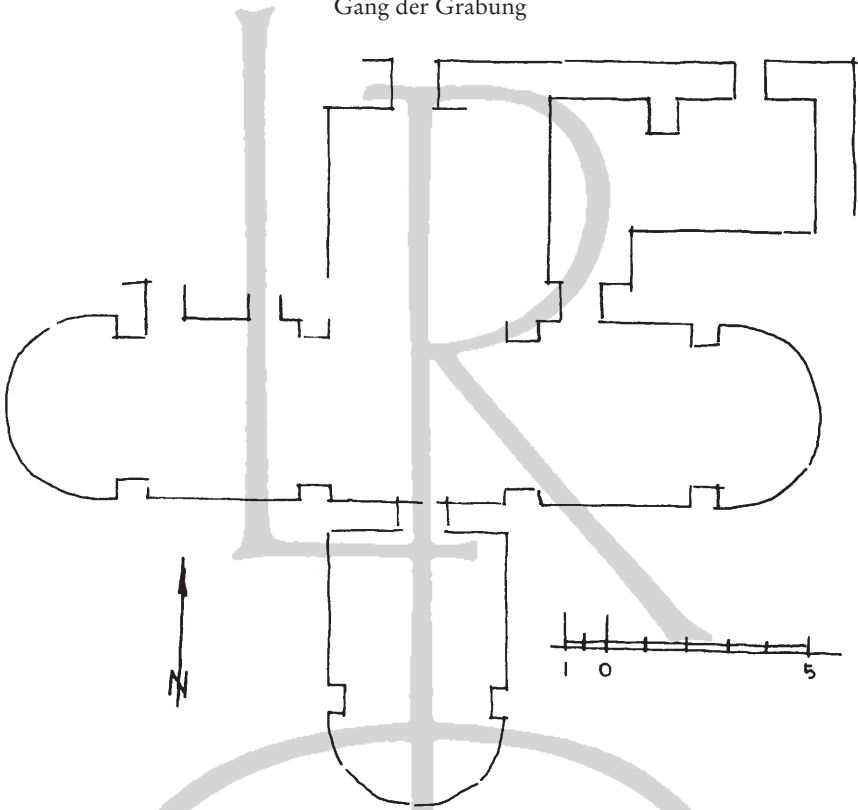
8 February 1949: The building seems to have been for different dwellings. A group of chambers is very interesting for the way of its building. It has a middle door that leads to a hall. To the right and left are two semi-circular chambers and in front of the hall is a third chamber in the same way³⁷ (**Fig. 9**).

Fig. 9. Hall with semicircular chambers

36 Es handelt sich hierbei um den Trikonchos der Bauanlage A.

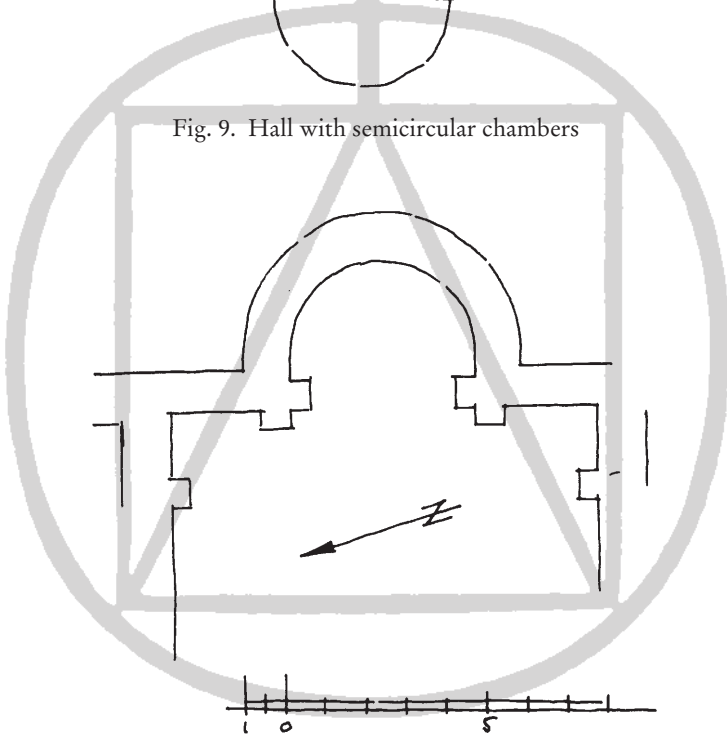
10 February 1949: The south of the building ends with a draining canal but not deep and does not resemble the draining system of the convent. The clearance of the part to the east of the semi-circular chambers is a big chamber ending on the east with a semicircle³⁸ like the previous ones. The work is on the east part of the building outside the chambers (**Fig. 10**).

Fig. 10. Big chamber with a semicircle outside of the chambers; later identified as a church

38 Es handelt sich hierbei um die Kirche der Bauanlage A.

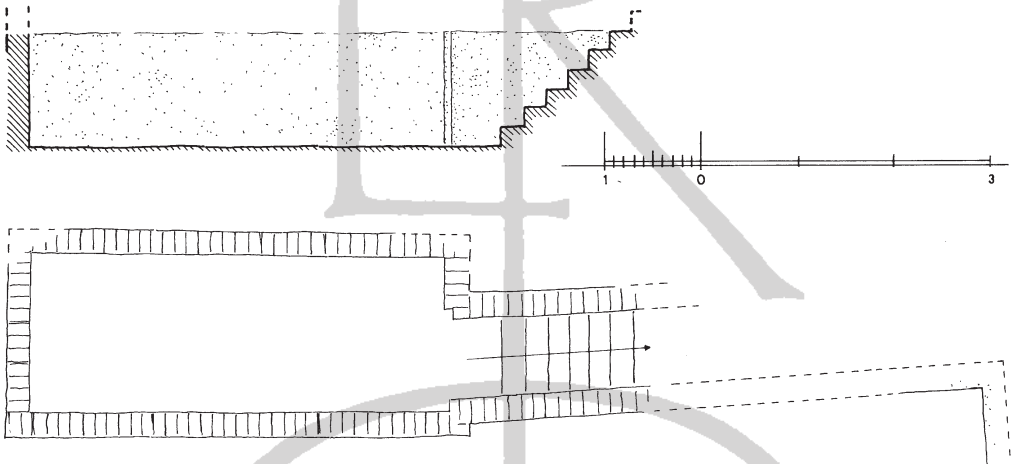
tomb no. 1, in which was found at the head of the owner a rectangular piece of ivory in a very bad state of preservation. After we treated the piece with gomalaka we found that it was inscribed with Coptic letters as shown on the photograph (Taf. 14d). In tomb no. 14 (Fig. 11) traces of two bodies were found, buried each one in a coffin. They were wrapped in cloth with threads of thin gilt material. Near the south-west corner was found a conical silver seal bearing the name of *Kosmas*. The tomb itself was built with mud bricks. The steps are on the west side⁴⁰.

Fig. 11. Tomb no. 14 (Für den Grundriß wurden die Maße von M.A.M. RASLAN übernommen.)

40 Aus der beigefügten Skizze (Abb. 11, mit Maßen) geht hervor, daß es sich bei diesem „tomb 14“ um die Grabanlage im Hof vor der Kirche handelt. Nach DU BOURGUET, *Découvertes* 83f, dessen Angaben wohl auf einer Notiz des Ausgräbers beruhen, wurden die übrigen Gräber nördlich außerhalb der Buanlage B gefunden.
